Addendum to

FINAL REPORT

Shelter and Component Testing OFDA transitional shelters: materials, techniques and structures (Supplementary Test)

Project Number: WOW12-2012-02-A

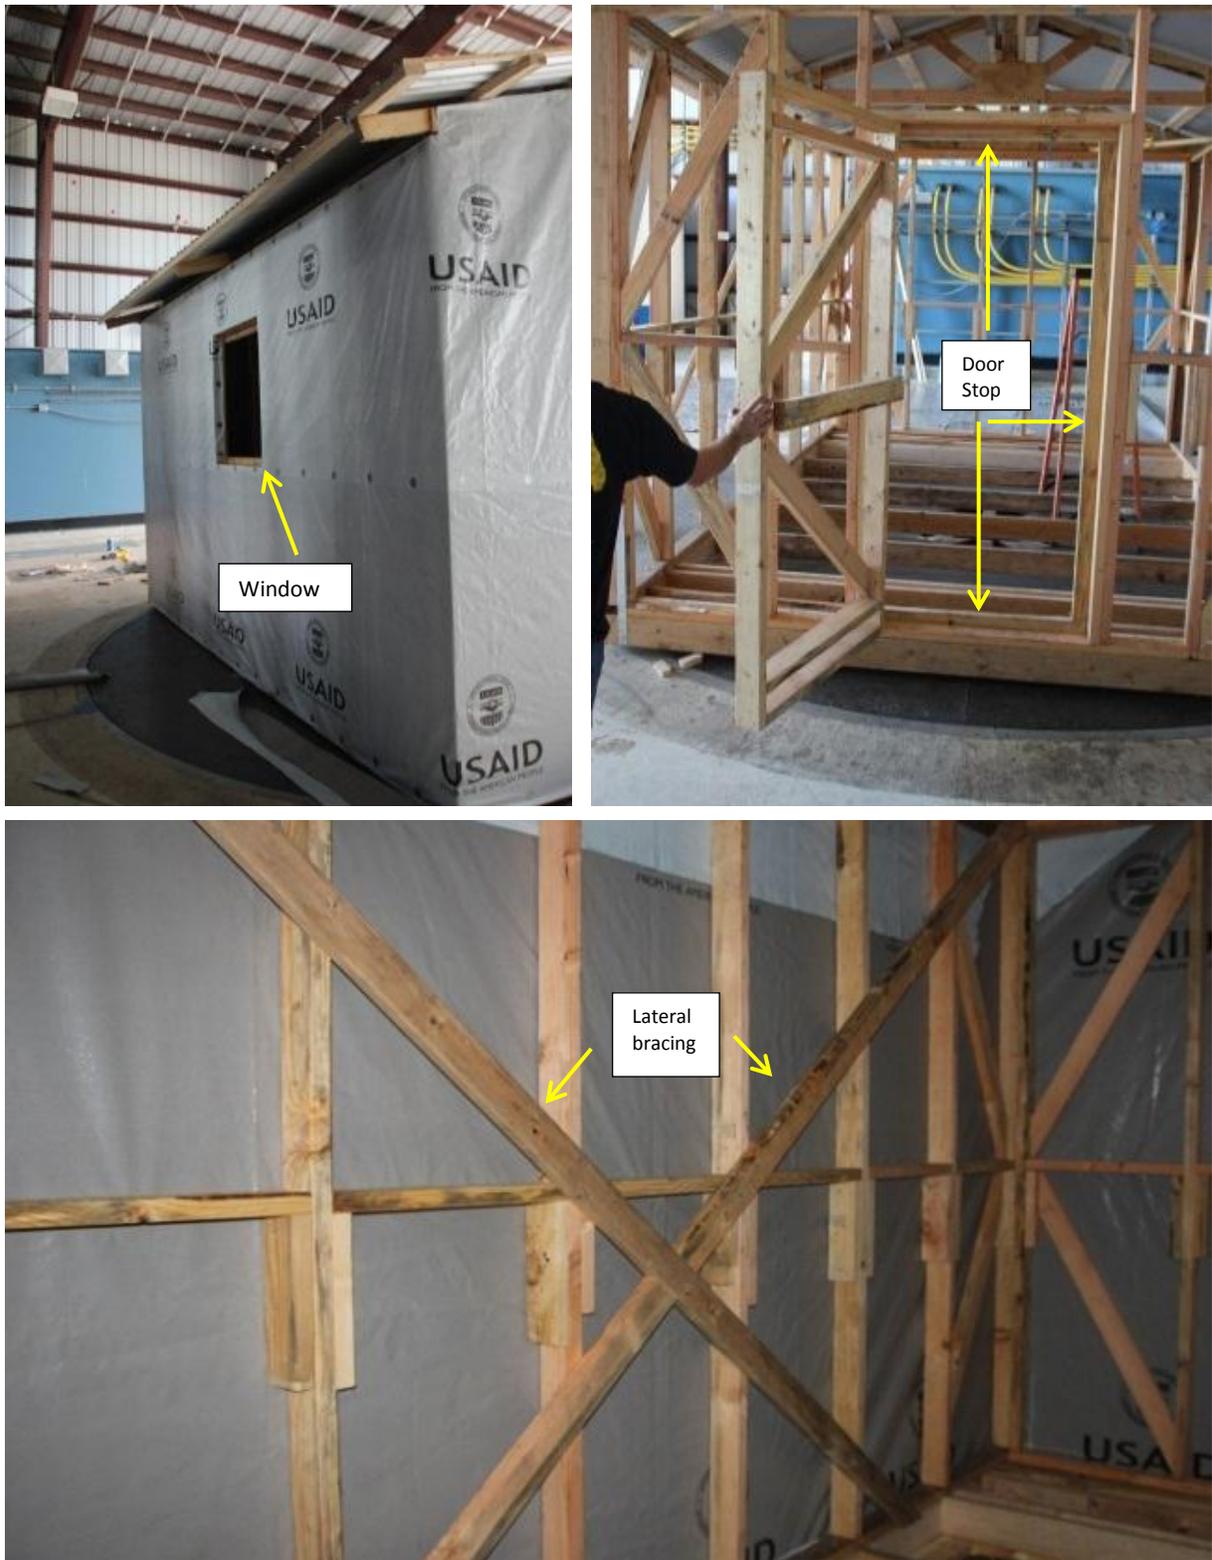
- Window on a non-gable end wall with a stop molding (built of 2-in x 4-in lumber) around the window frame.
- Provide continuous door stop molding all around the door opening and reinforce the hinge connections.
- Additional lateral bracing on non-gable end walls. A diagonal x-brace spanning the length of the walls was installed on both non-gable end walls.

Figure 3 - T-Shelter model improvements for T-Shelter 3 testing

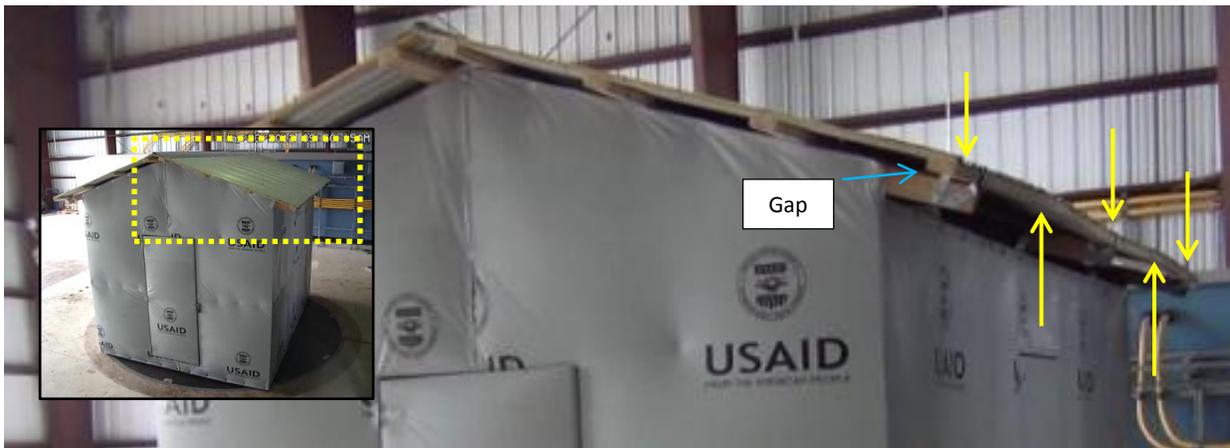
At the initial test speed (85 mph) it was observed that the T-Shelter structure was strong enough to be able to sustain the wind forces. No damage was noted on the framing or cladding. It is noteworthy to mention two effects on the T-Shelter as a result of the wind angle of incidence and the framing characteristics. At 0° there are sufficient uplift forces generated to cause a noticeable deformation on the leading edge purlin. A gap between the top chord of the truss and the purlin can be seen at one of the corners. The connections made with smooth shank nails were not adequate to prevent the nails from being pulled out under the uplift forces. The hurricane straps were shown to be effective to secure the purlins down to the trusses (Figure 4).

Figure 4 - Windward purlin deformation from uplift forces at 85 mph and 0° angle of attack

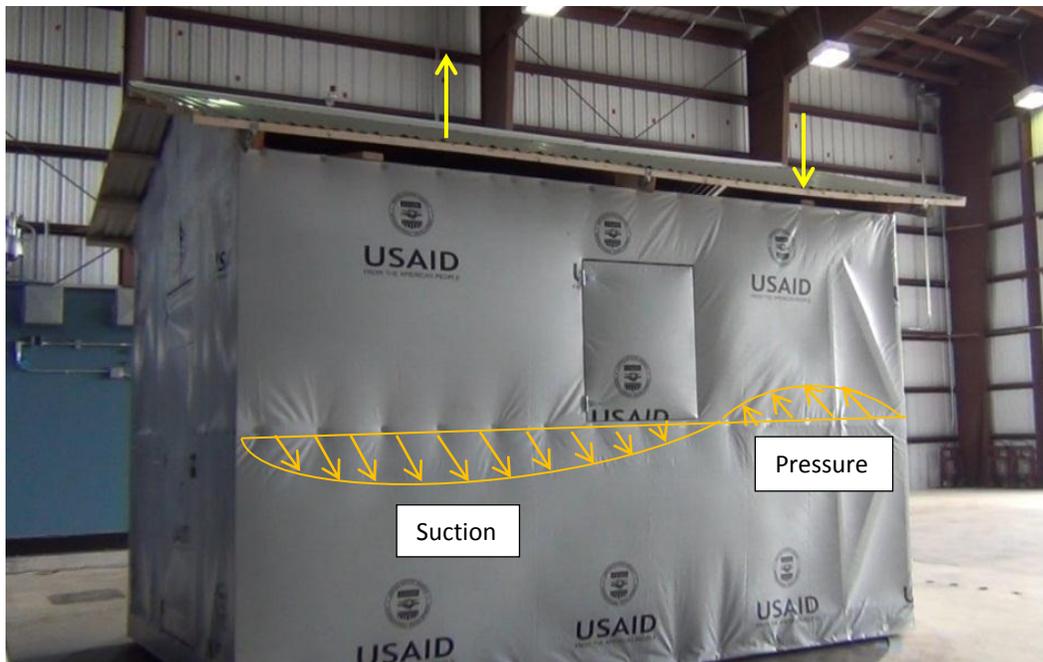
The deformation of the plastic sheeting suggested that when the wind had a 90° angle of attack, the flow separated near the leading edges and reattached further downwind. This is shown on Figure 5: bloated plastic surfaces at the windward side (suction) and plastic being pushed against the frame on the back (pressure). The roof also seemed to be susceptible to this effect, particularly with the long unsupported spans of roof structure. The edge purlins can be seen deforming by the action of the wind-induced forces.

It is important to consider that this model only had 3 roof trusses providing clear spacing of 7-ft between trusses. The spacing of the rafters was sub-optimal. The length of unsupported roof span was chosen for this structure to provide a comparable test with T-Shelter 1 and T-Shelter 2 in previous tests.

Figure 5 - T-Shelter 3 test at 85 mph and 90° angle of attack

The goal was to prove that a stronger roof structure with the same spacing as T-Shelter 1 (weak construction T-Shelter from previous experiments) should be able to withstand hurricane force winds. Even with its stronger construction, large unsupported spans allow for greater deformations and flexibility. The vulnerability can be decreased by adding more trusses and reducing the clear spacing by half.

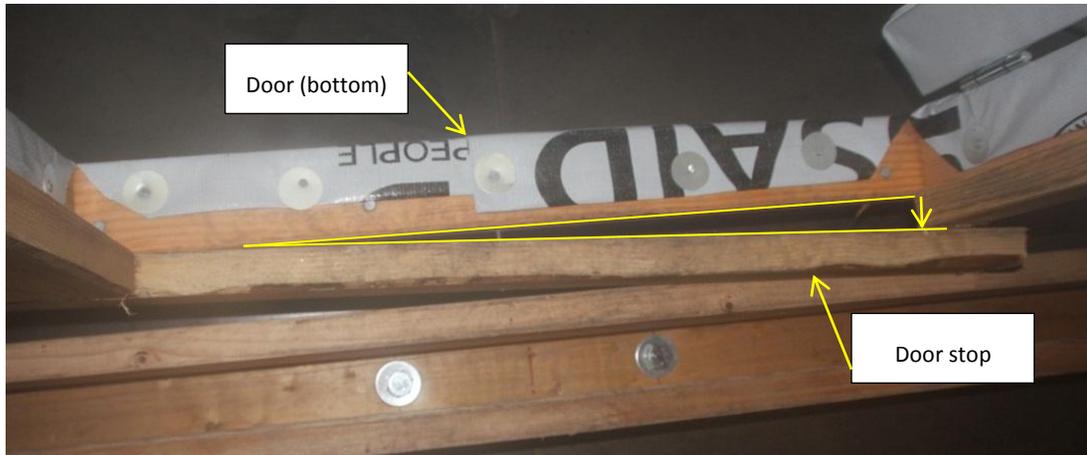
Furthermore, the increase in speed from 85 mph to 95 mph did not produce noticeable damage on the outside of the shelter. The additional lateral bracing seemed to be effective to transfer the forces and reduce the deflection at 90° angle of attack. The reinforced door hinges and door stop are believed to have provided additional support and strengthened the door system. No damage to the door was observed. While inspecting the inside of the shelter it was observed that the door stop did transfer the loads from the door to the frame. The bottom section of the door stop was partially pulled out from its attachment (Figure 6). This was a consequence of a construction flaw, where the nails were driven into the gap between the bottom plate and the platform.

Figure 6 - Bottom door stop pulled-out

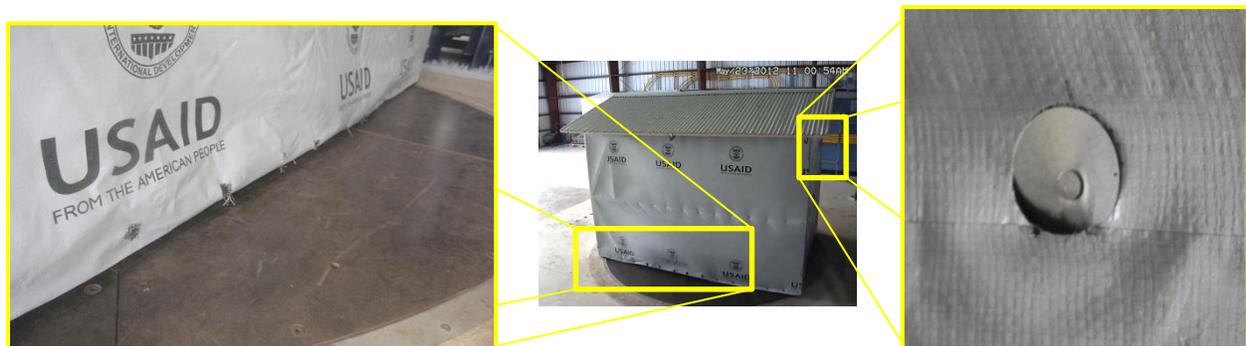
With the wind speed increased to 100 mph, sections of the OFDA plastic sheeting were pushed harder into the sharp edges of the tin caps. It is presumed that either the internal pressure build-up from air leaking through the shelter openings or the aerodynamic forces (suction) created on the wall surfaces, or a combination of both, caused the tin caps to start cutting through the plastic (Figure 7). It demonstrated that tin caps transfer the concentrated loads from the nail head to a bigger area on the plastic, but it's sharp edges can cut through it under repetitive loading. It is believed that a material with blunt edges (i.e. wood battens) might be a better option to enhance the durability of the USAID/OFDA plastic during repetitive loading and provide a surface to distribute the forces.

Figure 7 - Plastic puncture by tin cap discs

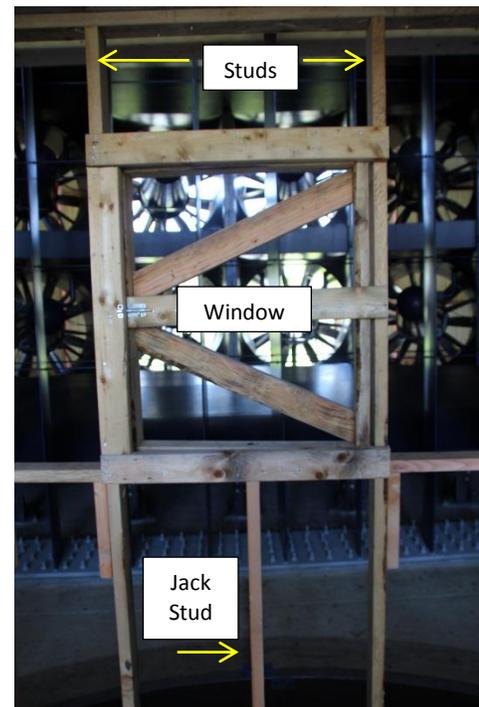
1. The wind acted on the long wall that had an opening (window). The framing had vertical studs discontinued because of the window opening. A jack stud (Figure 8) was provided under the window sill but no cripple stud (shorter stud in window/door header) over the header. The spacing between studs was increased from 24-in on center to 32-in on center at the window opening.

Figure 8 - Window framing

- Adequate reinforcement at framing discontinuities must be provided to ensure the structure's ability to transfer the loads uninterruptedly to the foundation and distribute them along the structure. Door and window openings are discontinuities on the frame system that may become a weak point of the structure because of high stress concentrations on the discontinued frame members. Required elements to be included on the framing of door and window openings include: header, top cripples, and trimmer and jack studs (see Figure 10).

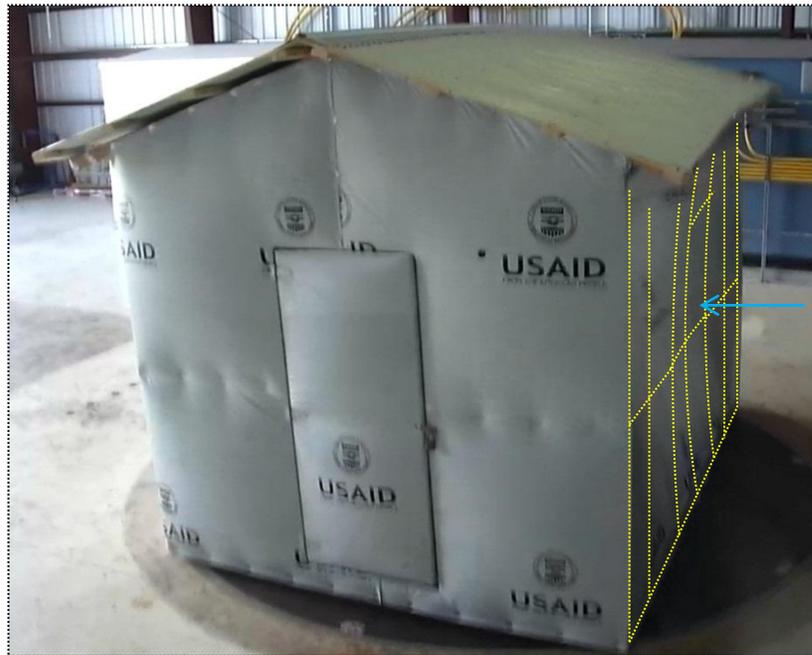
2. While reviewing the video it can be observed that there was a sudden deformation of the wall in its mid-section (close to 1 min into the test). The window section of the wall buckled inwards but did not detach from the rest of the frame (Figure 9). Until this moment the structure was still standing and the damage could have been repaired.

3. An inspection of the damaged wall after the test found that none of the studs around the window section fractured. Therefore, it is assumed that the wind-induced forces on the wall slowly pulled the nails out of the wood members that connected the studs to the top and bottom plates. There was no evidence of the nails failing from shear.

Figure 9 - Windward wall deformation at 0° angle of attack and 110 mph

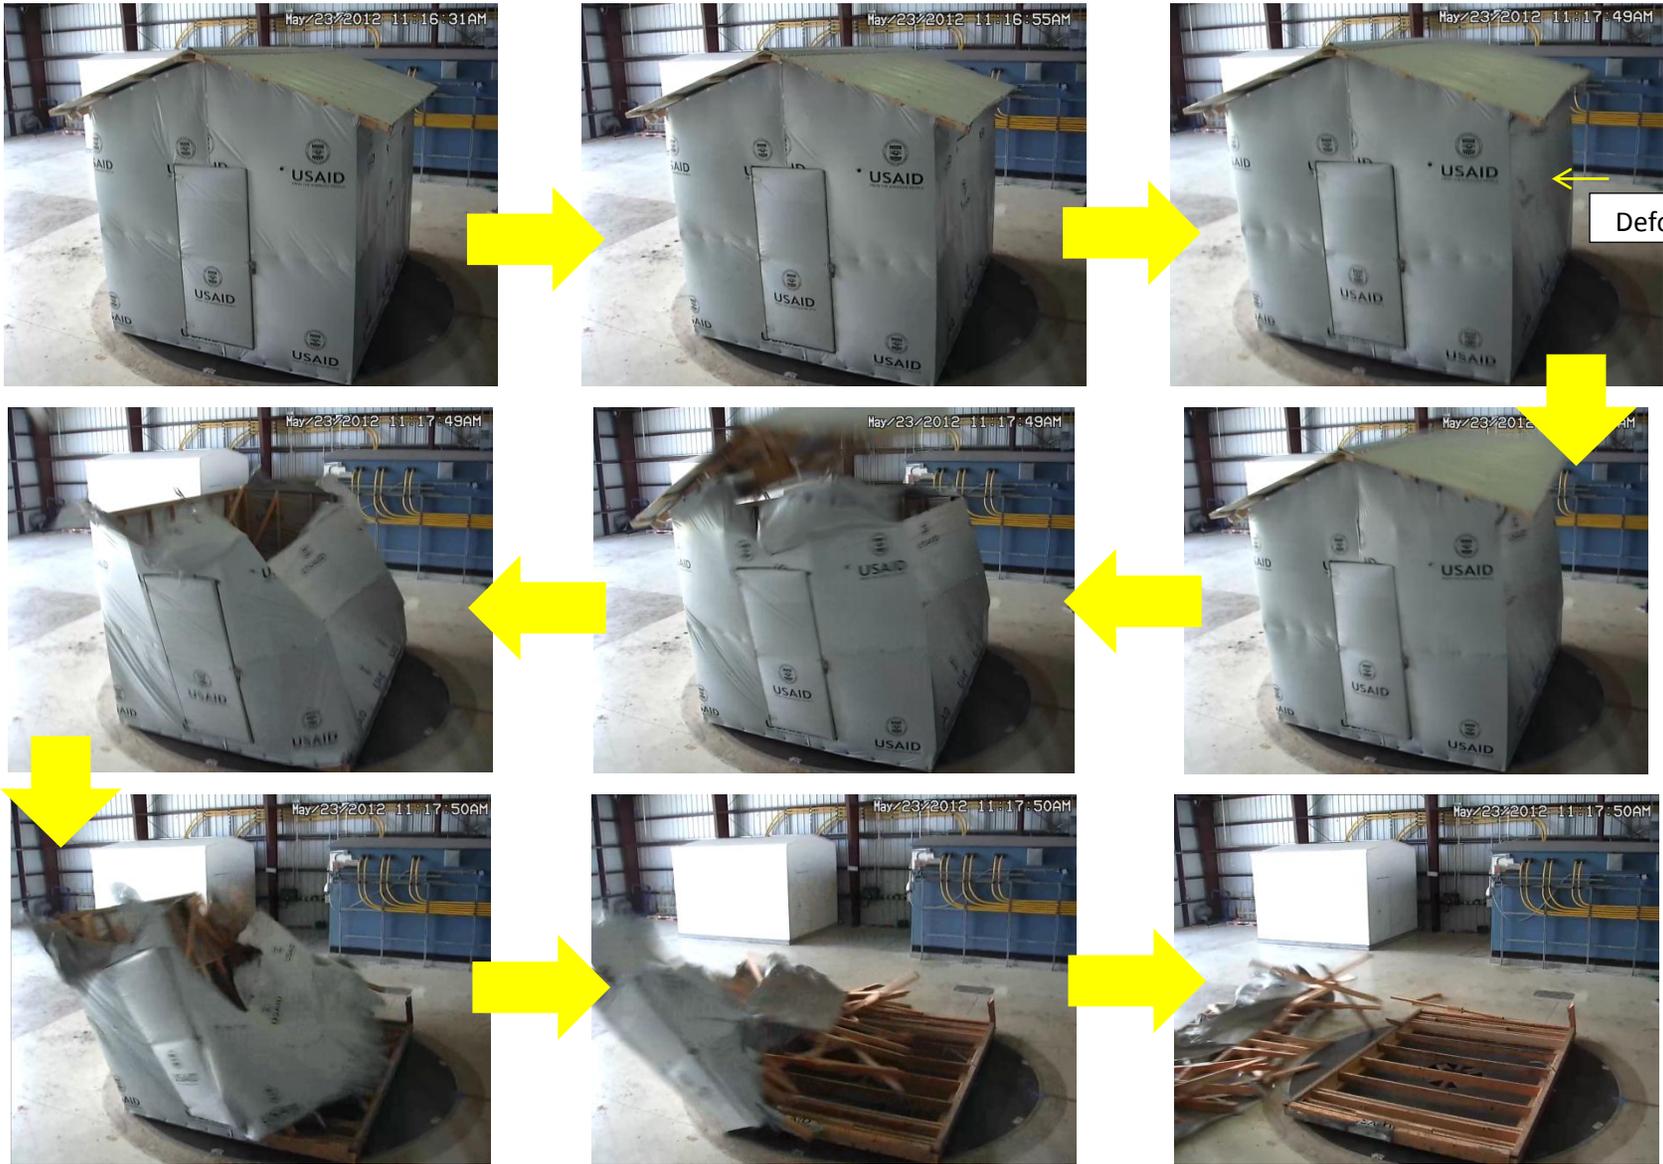
The frame on T-Shelter 3 failed at 110 mph and an angle of attack of 0°. It is believed that the failure mechanism is as follows:

4. After the windward wall collapsed, it provided no support for the middle roof truss.
5. The roof system was now supported by two trusses on each corresponding gable-end wall creating an unsupported span of 14-ft.

6. One of the hurricane straps that connected one of the gable-end trusses sheared and at that moment the roof system completely disconnected from the shelter's walls.
7. With no structural members supporting the mid-span wall section and the roof diaphragm gone, the walls collapsed under the wind loads.

Figure 11 - Shelter 3 failure

- Use of smooth shank nails should be discouraged. Ring shank nails were used for T-Shelter 3 only to fasten cladding to the frame. For these tests it was specified that framing should be done using 12D common nail. There is a big improvement in the pull-out resistance of ring-shank nails compared to smooth shank nails. The use of ring-shank nails is recommended for framing construction.
- To make the structures less vulnerable to failure under high wind conditions, a factor of safety should be incorporated into the different construction techniques. It was observed that there is no redundancy in the structural elements of the shelter. Once one of the members is weakened and fails the rest of the structure is compromised and most likely to collapse. By adding redundant elements, in case the roof fails, an internal or partition wall can help distribute the windward wall forces.
