Progress Report: January 1, 2014 to January 31, 2014

USAID and the Government of Vietnam continued implementing the Environmental Remediation of Dioxin Contamination at Danang Airport Project launched in August 2012.

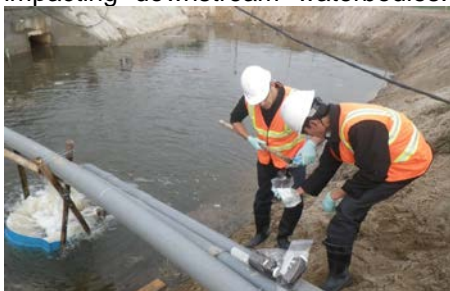
Sampling Sen Lake during dewatering (Photo: CDM Smith)

USAID contractors continued extensive monitoring, inspection, and testing of environmental media, equipment and construction materials to ensure no contamination leaves the Project site and that construction activities meet design specifications. In January 2014, this included more frequent collection of water samples from Sen Lake to confirm dewatering activities were not negatively impacting downstream waterbodies.

While the first phase of thermal treatment is conducted, USAID contractors will also excavate contaminated sediment from Sen Lake and the surrounding wetlands for the second treatment phase. In preparation for excavation, contractors began dewatering Sen Lake and clearing floating vegetation. Based on results from past investigations at the Danang Airport, the floating vegetation does not require treatment and will be reused on the Project site for erosion control. Water samples are routinely collected to ensure contaminated sediments suspended (floating) in the water do not leave the site.

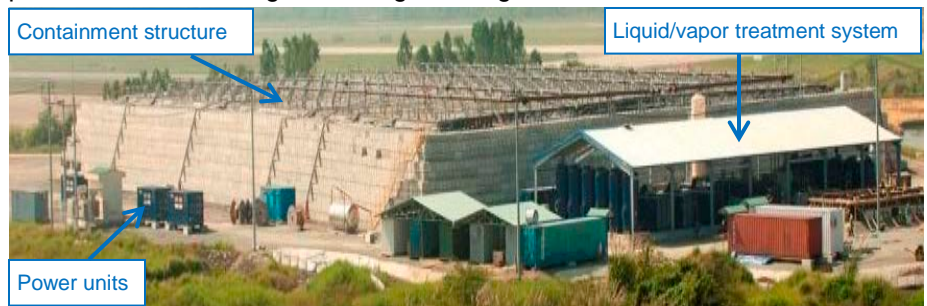
Containment structure and liquid/vapor treatment system (Photo: Tetra Tech)

USAID contractors completed installation of the heating elements inside the heater wells that are drilled through the containment structure. Powered by electricity, these heating elements/wells will raise the temperature of the contaminated soil inside the containment structure to the target treatment temperature of 335°C. The electrical connections between the containment structure and the power units were also completed in January 2014, and the power units were energized to begin testing the heaters.

USAID contractors continued construction of the liquid and vapor treatment system at the north end of the containment structure. The roof has been erected, and the cooling tower, granular activated carbon (GAC) vessels, separators, and scrubbers are being assembled and installed. Work also began to connect the piping systems between the various treatment system components. This secondary treatment system will capture and treat any remaining contaminants in the liquid and vapor phases that are not destroyed in the containment structure, where the majority of dioxin will be destroyed during heating.

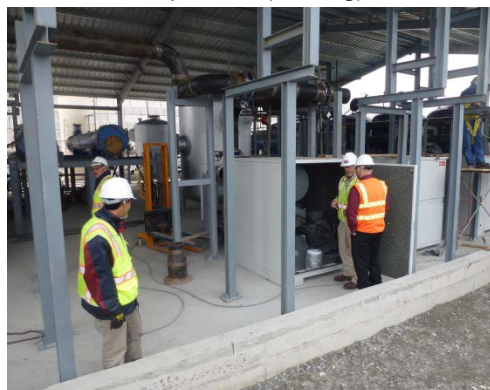
USAID contractors inspecting the liquid/vapor treatment system's blowers (Photo: CDM Smith)

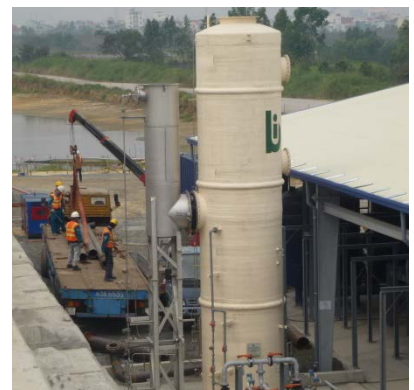
The liquid/vapor treatment system's quenching tower (Photo: CDM Smith)

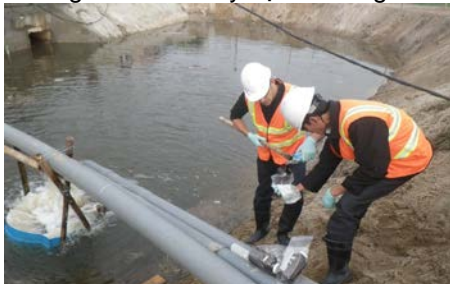
Lấy mẫu ở Hồ Sen trong khi tháo nước (Ảnh: CDM Smith)

Các nhà thầu của USAID tiếp tục giám sát, quan trắc và thử nghiệm rộng rãi môi trường, thiết bị và vật liệu xây dựng nhằm đảm bảo chất nhiễm bẩn không thoát ra khỏi khu vực dự án và các hoạt động thi công đáp ứng tiêu chí thiết kế. Vào tháng 01/2014, công tác kiểm tra còn bao gồm việc thường xuyên lấy mẫu nước Hồ Sen để xác nhận các hoạt động tháo nước không gây ảnh hưởng xấu cho thủy vực cuối nguồn.

Trong khi tiến hành xử lý nhiệt giai đoạn đầu, các nhà thầu của USAID cũng sẽ đào xúc bùn bị nhiễm bẩn từ Hồ Sen và vùng nước ngập xung quanh để xử lý trong giai đoạn sau. Để chuẩn bị cho việc đào xúc, các nhà thầu đã bắt đầu tháo nước Hồ Sen và thu gom thực vật nổi trên nước. Dựa trên kết quả khảo sát trước đây ở Sân bay Đà Nẵng, thực vật không cần phải xử lý và sẽ được dùng làm chất liệu ngăn chặn xói lở trong khu vực Dự án. Các mẫu nước được thường xuyên thu thập nhằm đảm bảo bùn bị nhiễm bẩn lơ lửng trong nước không thoát ra bên ngoài phạm vi công trường.

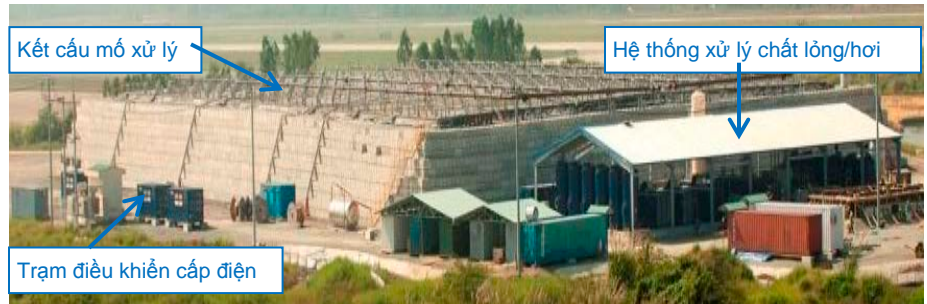
Kết cấu móng xử lý và hệ thống xử lý chất lỏng/hơi

USAID đã hoàn tất việc lắp đặt các bộ truyền nhiệt vào trong các giếng truyền nhiệt được khoan vào khắp kết cấu móng xử lý. Các bộ/giếng truyền nhiệt chạy bằng điện này sẽ nâng nhiệt độ của đất bị nhiễm bẩn trong kết cấu móng xử lý lên mức nhiệt mục tiêu là 335°C. Việc đấu nối kết cấu xử lý với hệ thống cấp điện cũng đã được hoàn tất vào tháng 01/2014 và các cấu phần đã được đóng điện để chạy thử các bộ truyền nhiệt.

Các nhà thầu của USAID tiếp tục thi công hệ thống xử lý chất lỏng và hơi ở đầu bắc của kết cấu xử lý. Phần mái đã được lắp đặt, đồng thời tháo làm mát, các thùng cacbon hoạt tính thể hạt (*granular activated carbon – GAC*), bộ phận tách, bộ phận xử lý cũng đã được lắp đặt. Việc đấu nối các hệ thống ống với các cấu phần xử lý khác nhau cũng đã bắt đầu. Hệ thống xử lý thử cấp này sẽ thu gom và xử lý những chất nhiễm bẩn còn sót lại ở dạng lỏng và hơi mà chưa được phá hủy trong kết cấu xử lý, nơi mà phần lớn lượng dioxin sẽ bị phá hủy khi nung nóng.

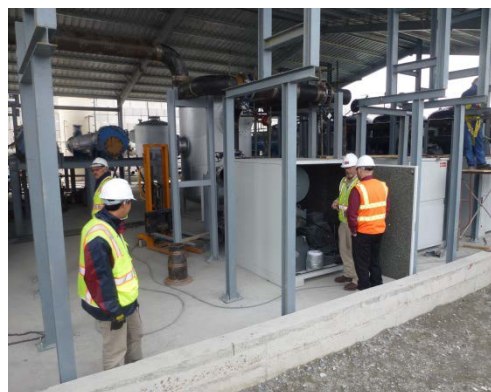
Các nhà thầu của USAID đang kiểm tra hệ thống xử lý chất lỏng/hơi (Ảnh: CDM Smith)

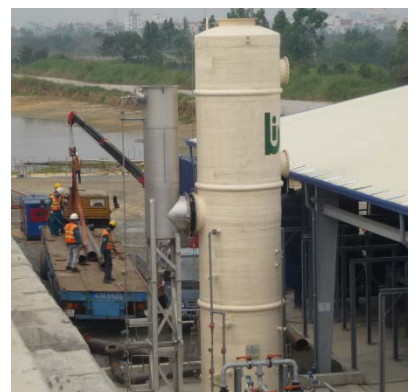
Tháp làm mát nhanh của hệ thống xử lý chất lỏng/hơi (Ảnh: CDM Smith)
